A Recommendation for an
ENHANCED FUJITA SCALE
(EF-Scale)

Submitted to
The National Weather Service
and
Other Interested Users

June 2004

WIND SCIENCE AND ENGINEERING CENTER
Texas Tech University
Lubbock, Texas 79409-1023

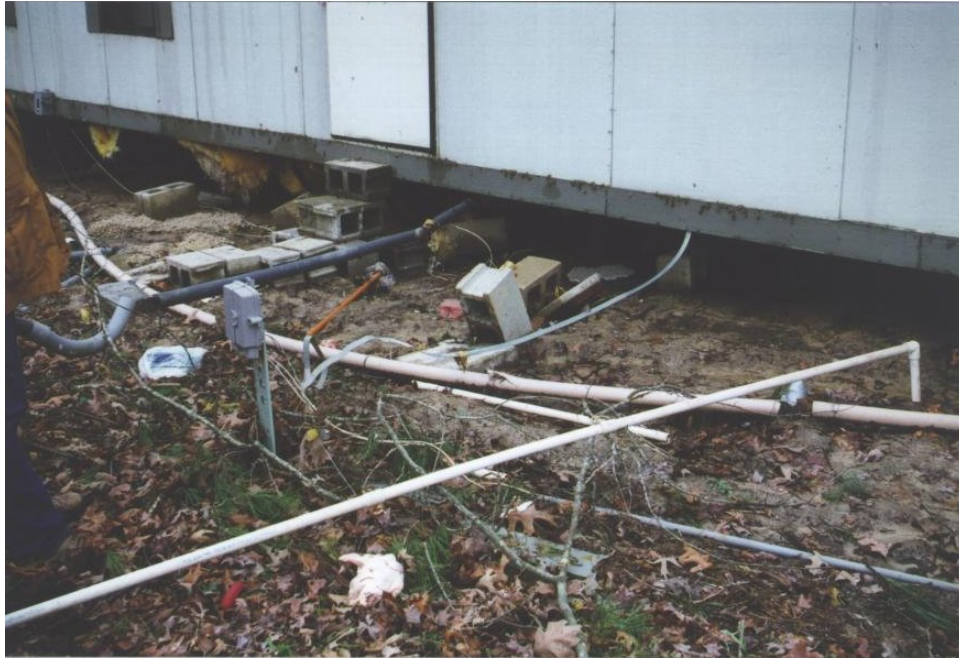
MHSW: DOD 3: Unit slides off block piers but remains upright

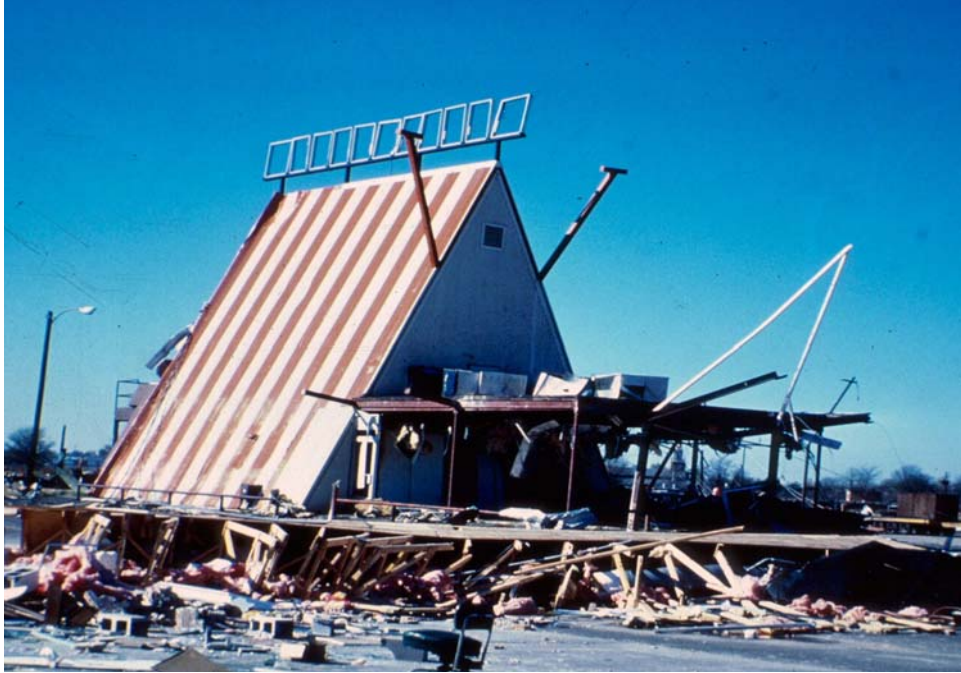
SRB: DOD 5: Canopies and covered walkways destroyed

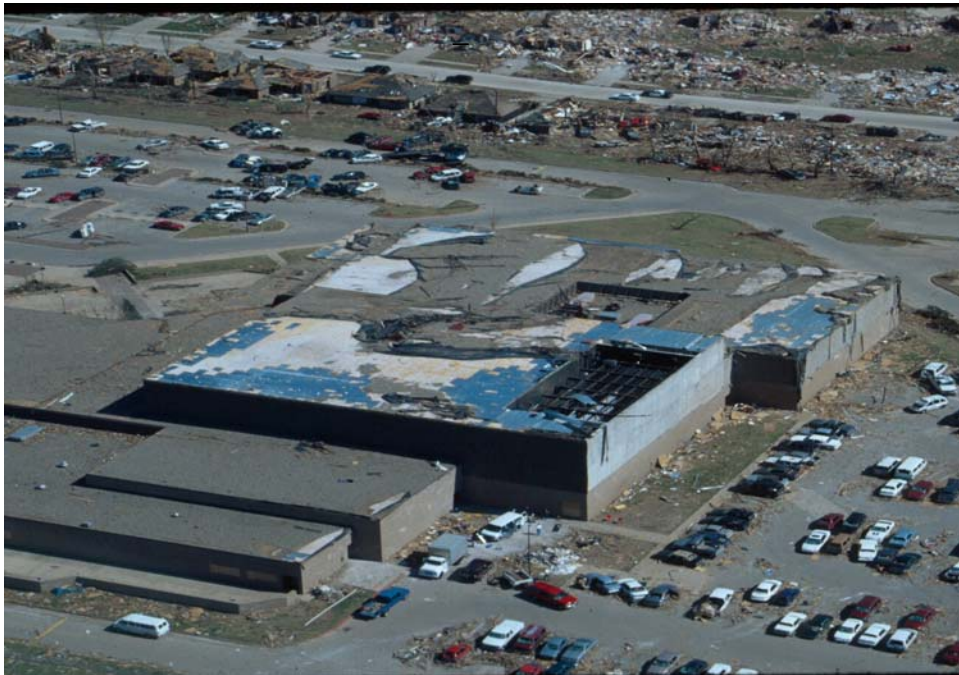
LSM: DOD 4: Uplift of some roof decking; significant loss of roofing material (>20%); loss of rooftop HVAC

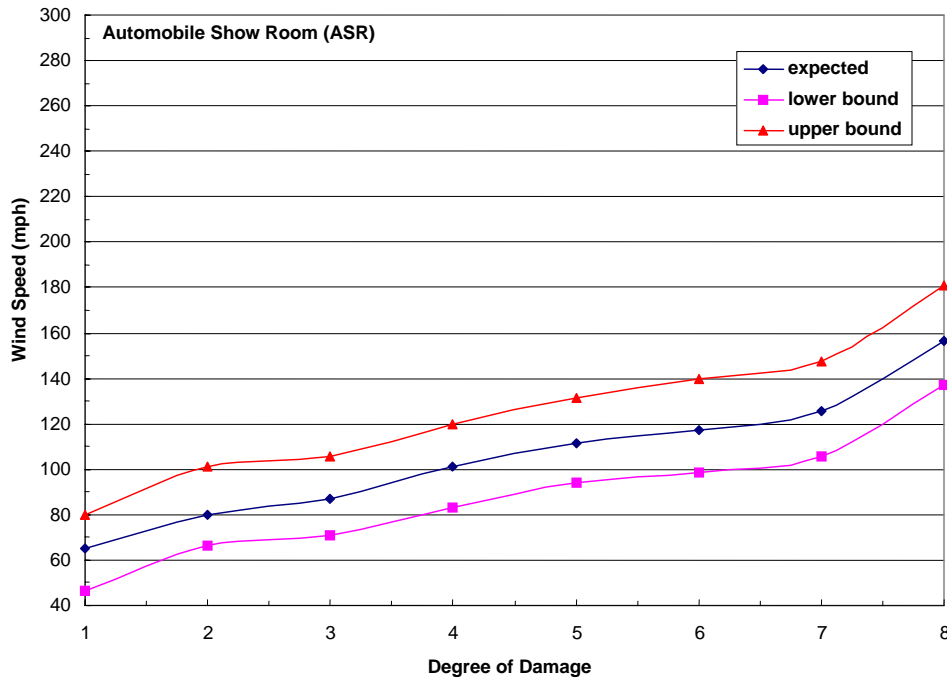
Wind Speed vs Degree of Damage

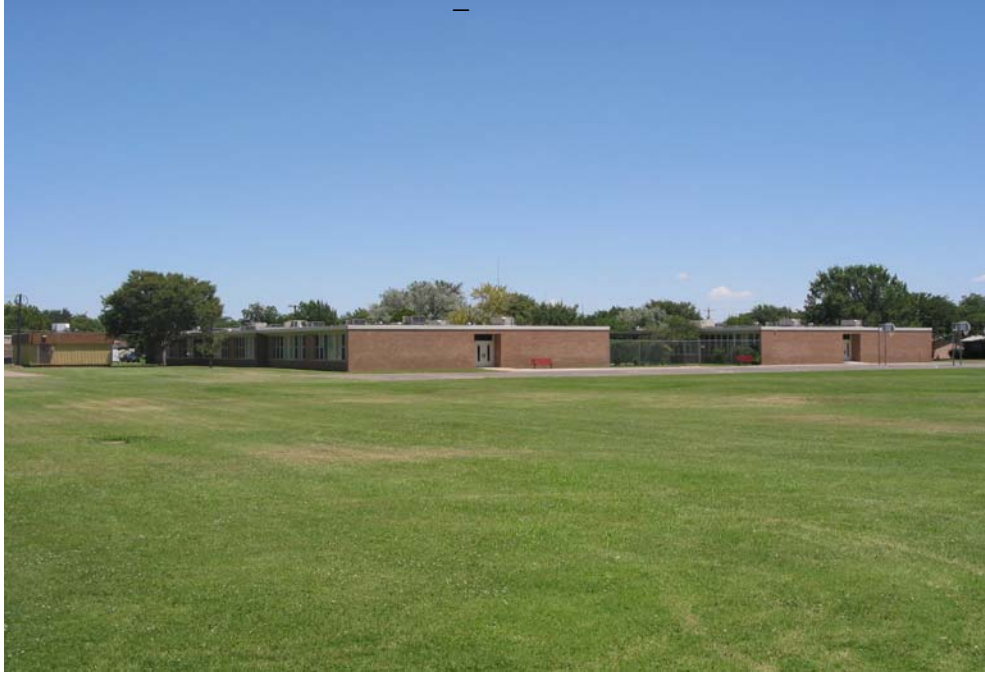
ES: Single story with flat roof; built-up roofing with gravel; brick veneer; large percentage of window glass; long interior hallways; load-bearing walls

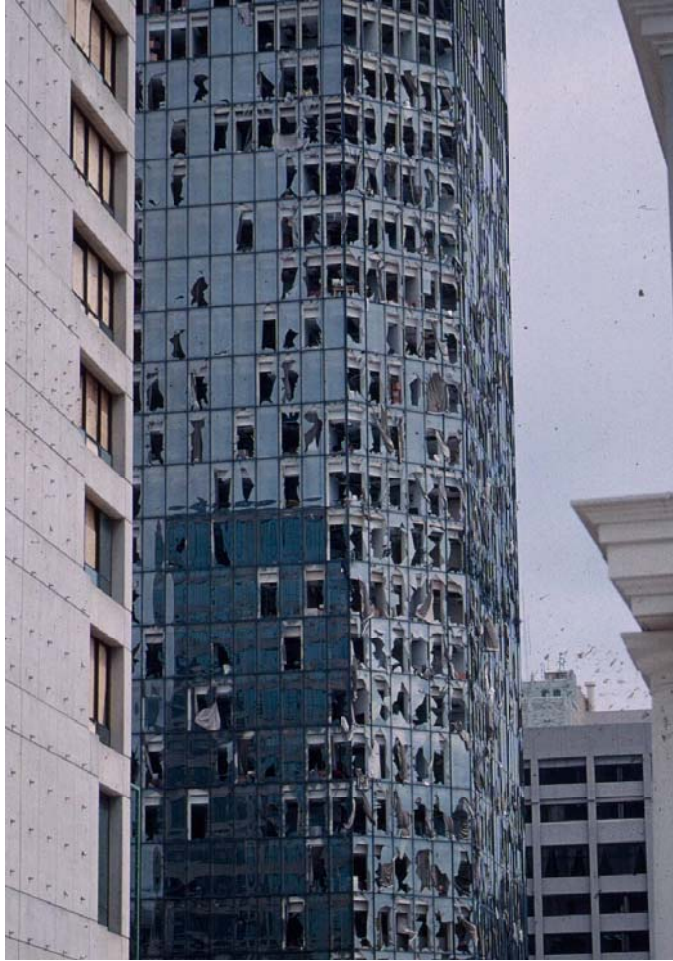
HRB: DOD 5: Broken glass in curtain wall; significant damage to building interior

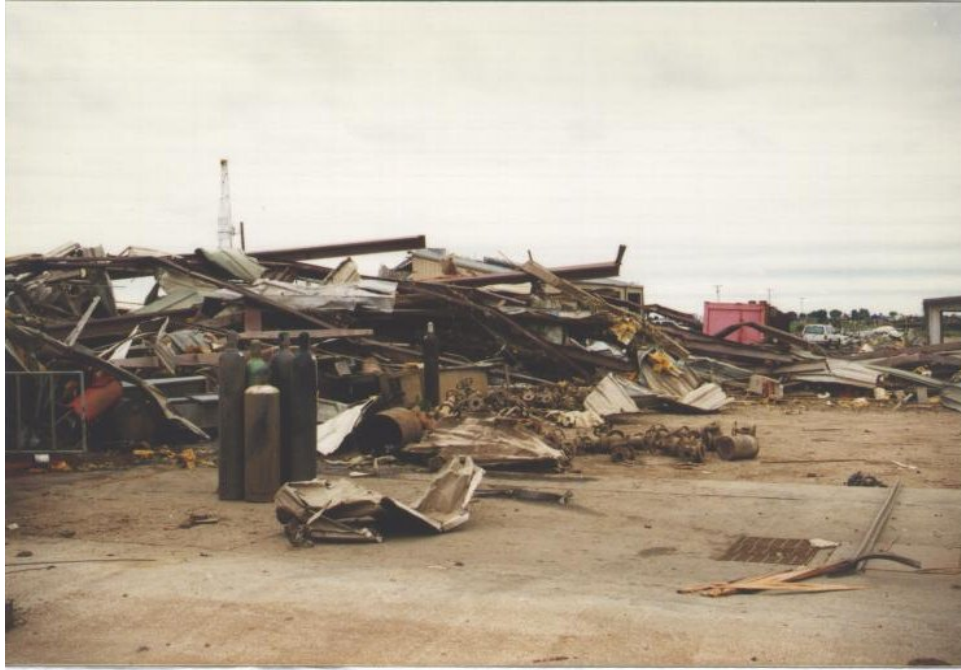
MBS: DOD 8: Total destruction of building
